Repair & Diagnostic Methods for RCC Structures

E. GOPALKRISHNAN,
Head-ADL & Consultancy Services

Dr.Fixit Institute - Structural Protection & Rehabilitation

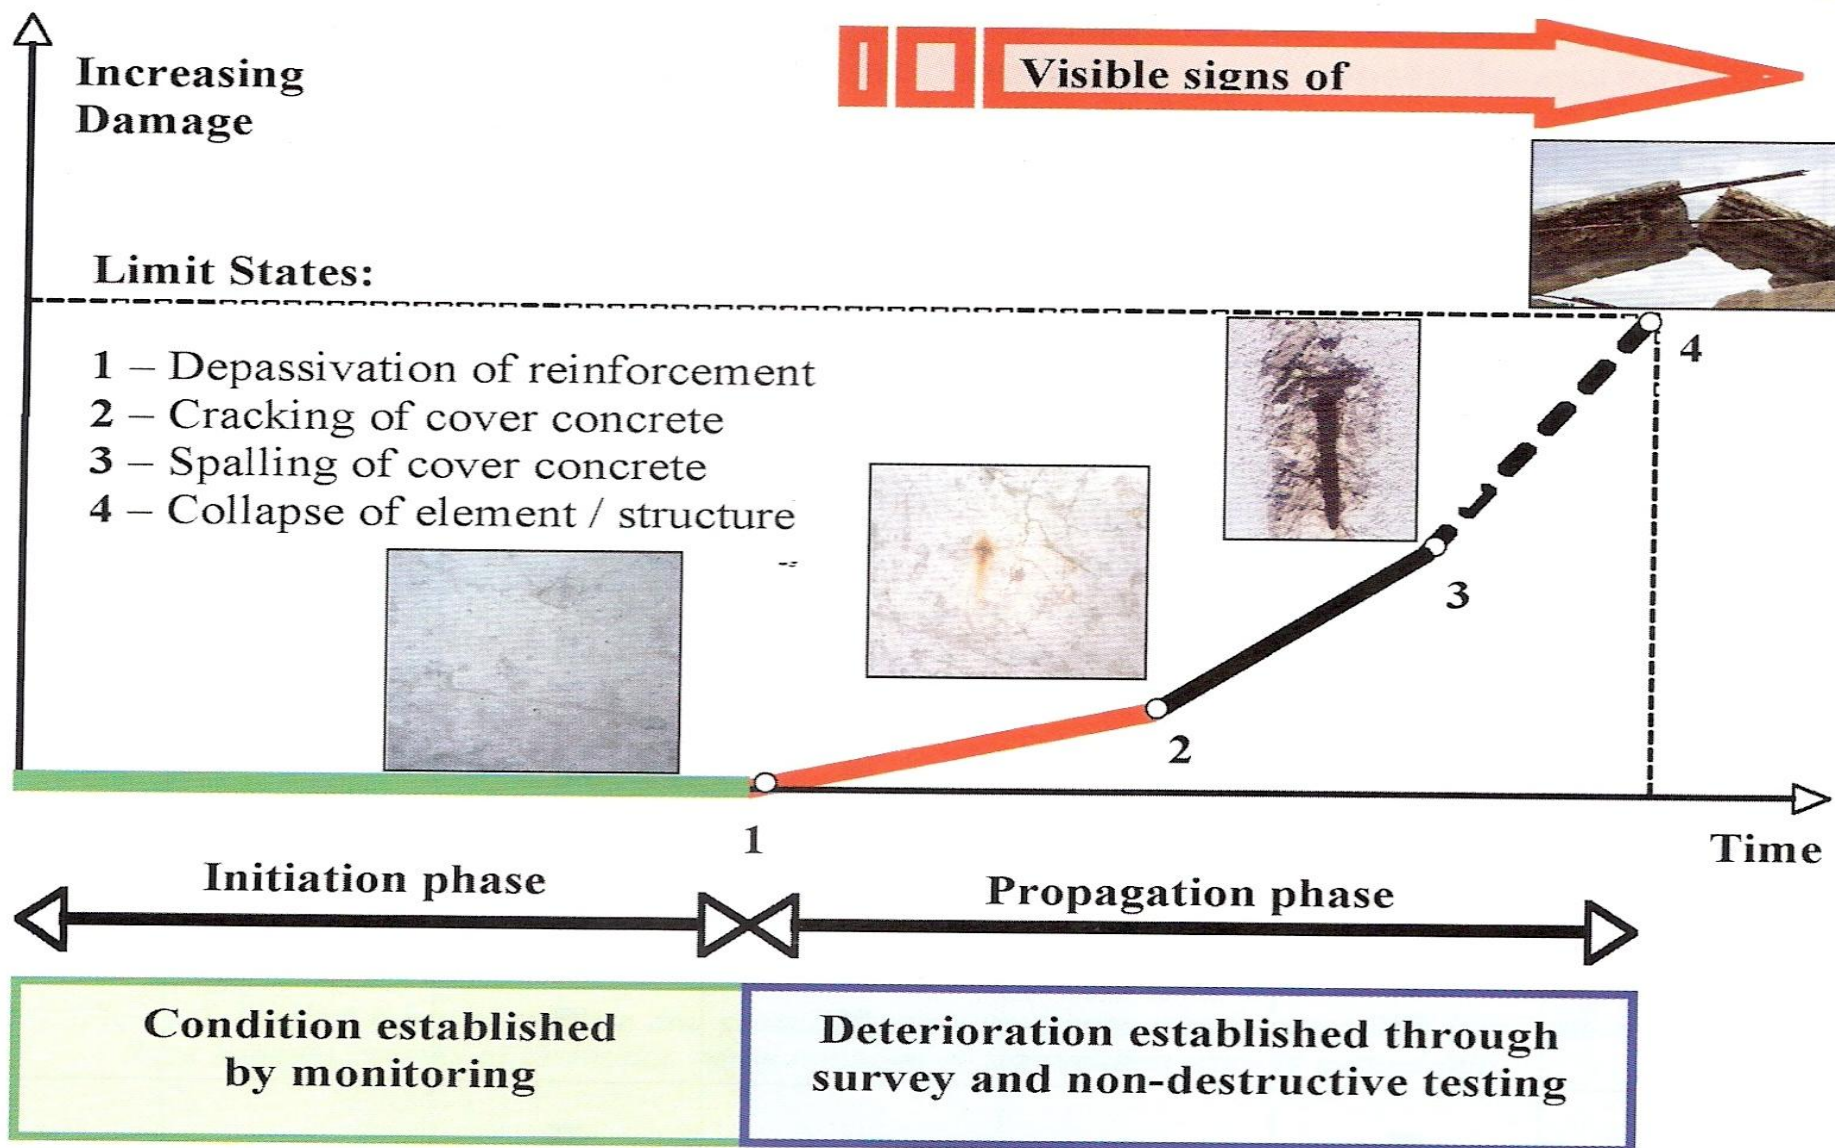
Induced Deterioration of a Concrete Structure

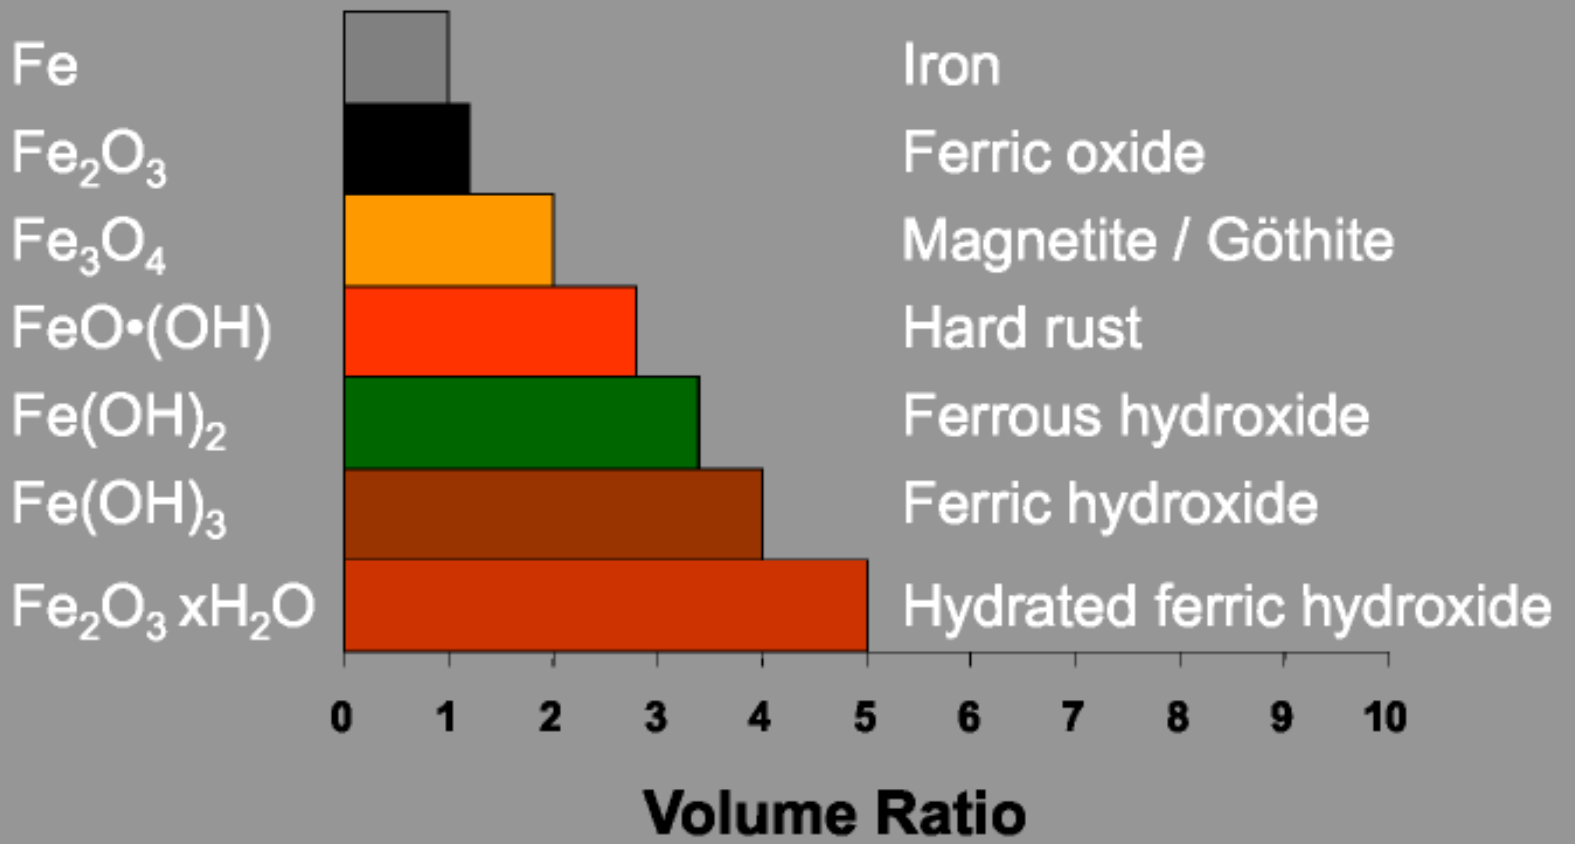
Corrosion process

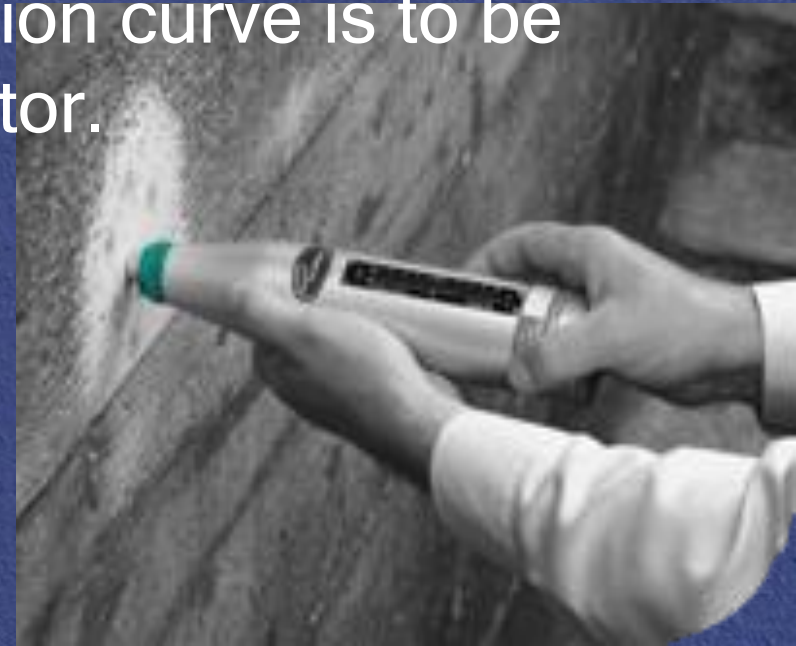
Schmidt Hammer

- Simplest & Quickest estimation of surface hardness of concrete
- Carbonation is not the only important factor influencing rebound numbers
- The strength estimated from the manufacturer's regression curve is to be multiplied by a time factor.

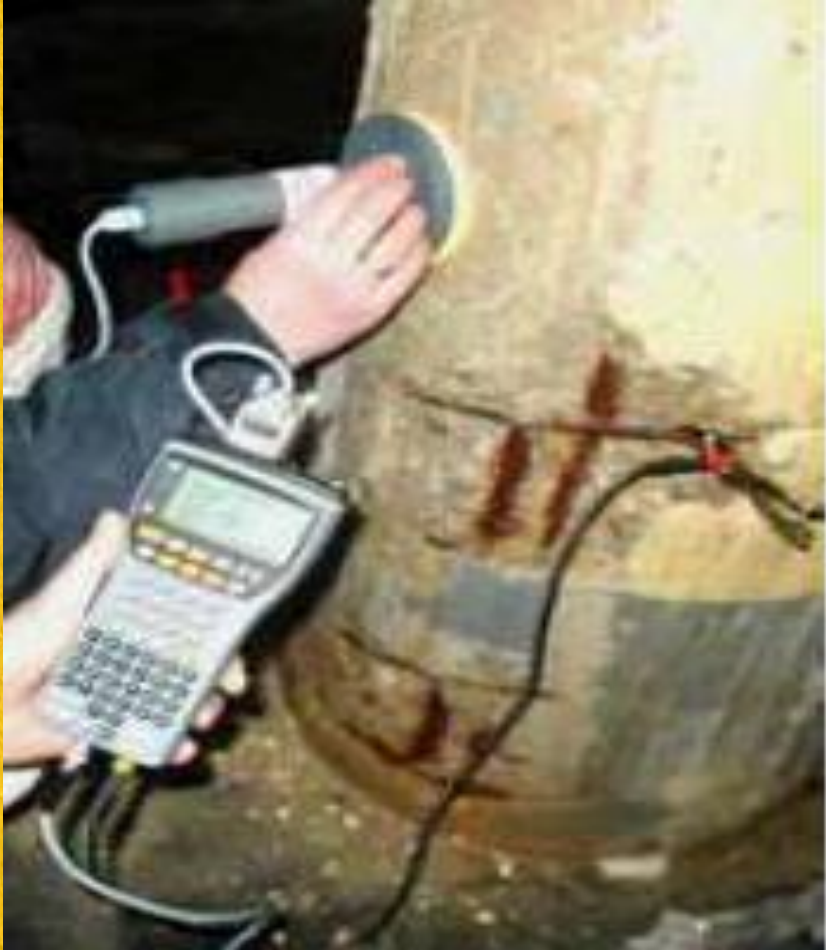
Corrosion Analyser

- Potential measurement (potential mapping), corrosion rate measurement, galvanostatic pulse technique (GPM)
- Linear polarisation resistance technique (LPR) and service life estimate.

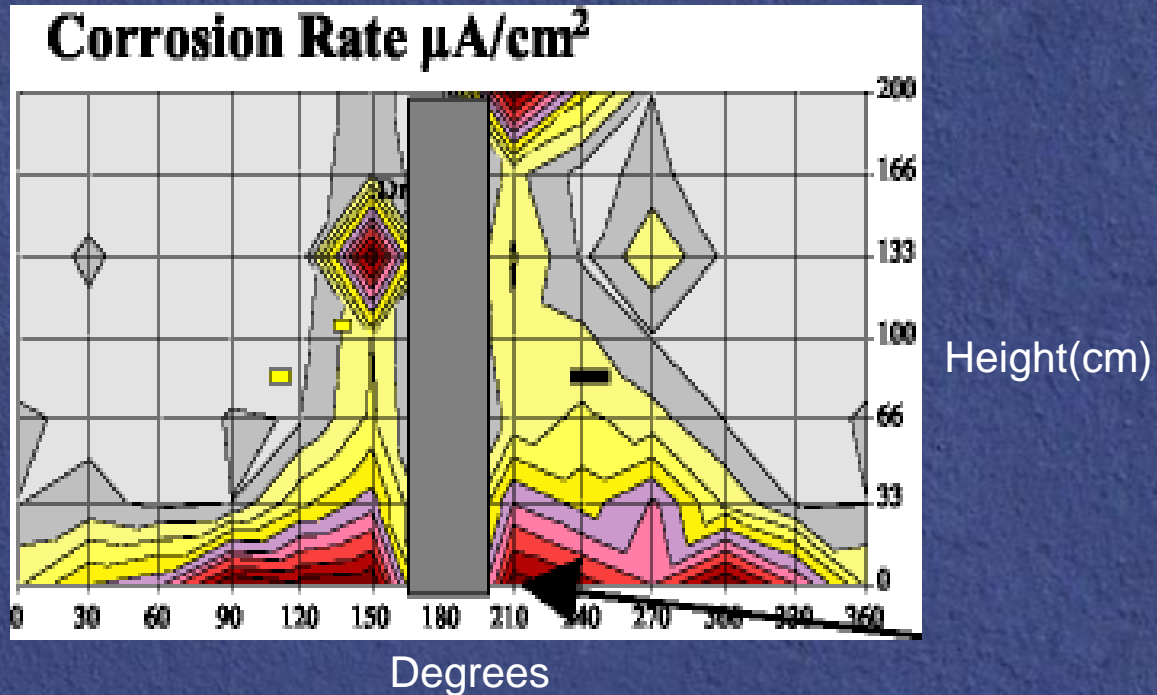
Rate of corrosion measured on circumference of the column

At the marked point rate of corrosion was $220\mu\text{m}$. For 20 years period@0.22 mm per year = 4.4 mm

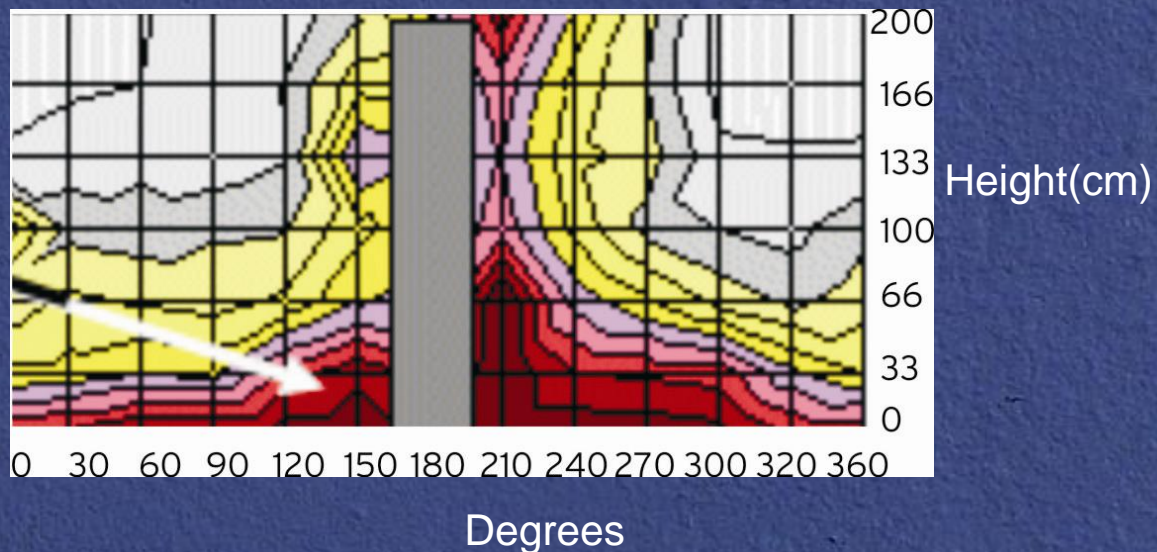
Half cell potential measured on circumference of the column
= - 500 mV

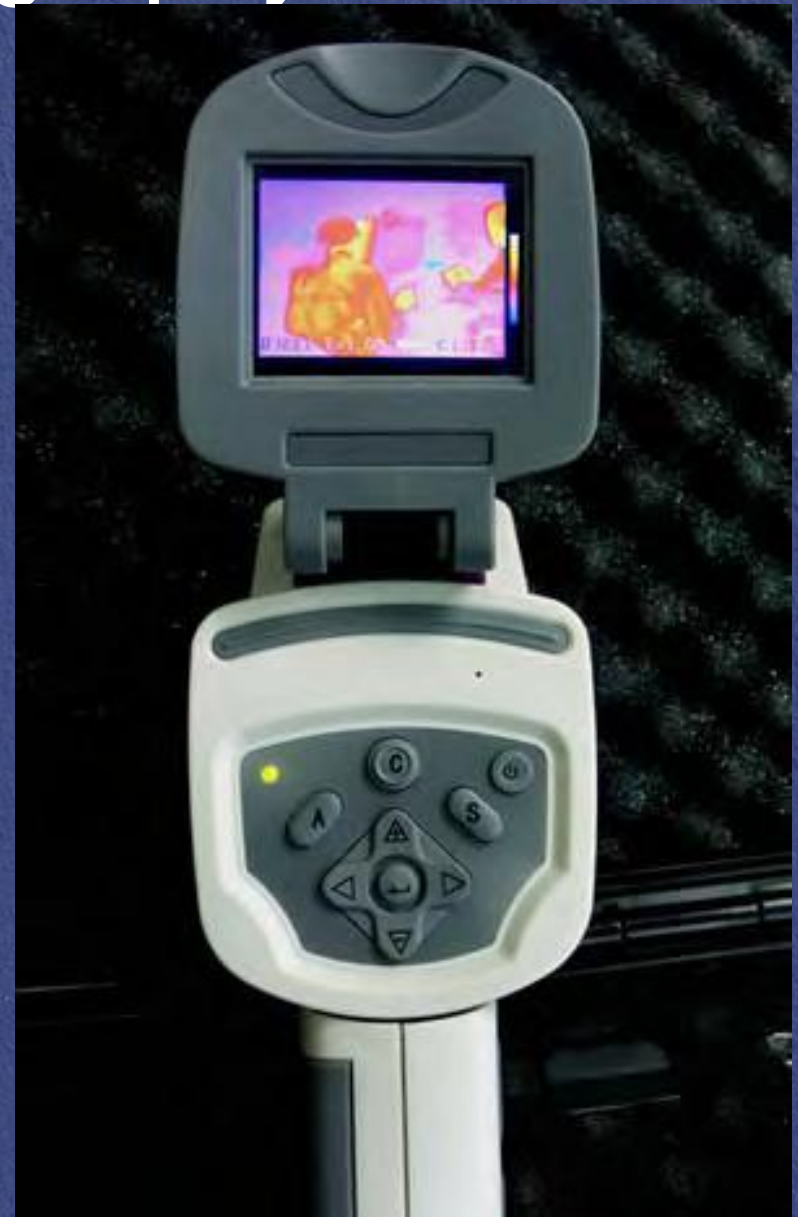
Potential
seepage

Potential
deboning
plaster

Potential
spalling
concrete

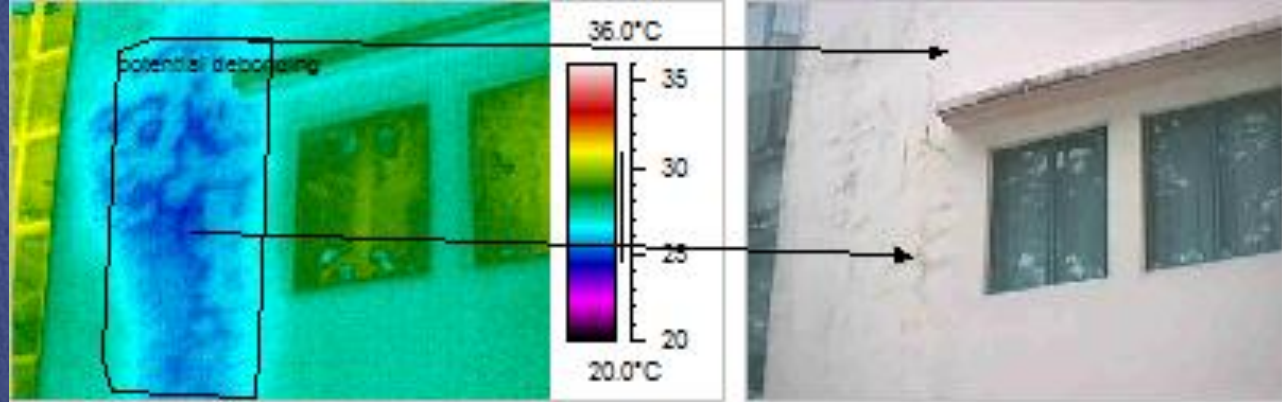
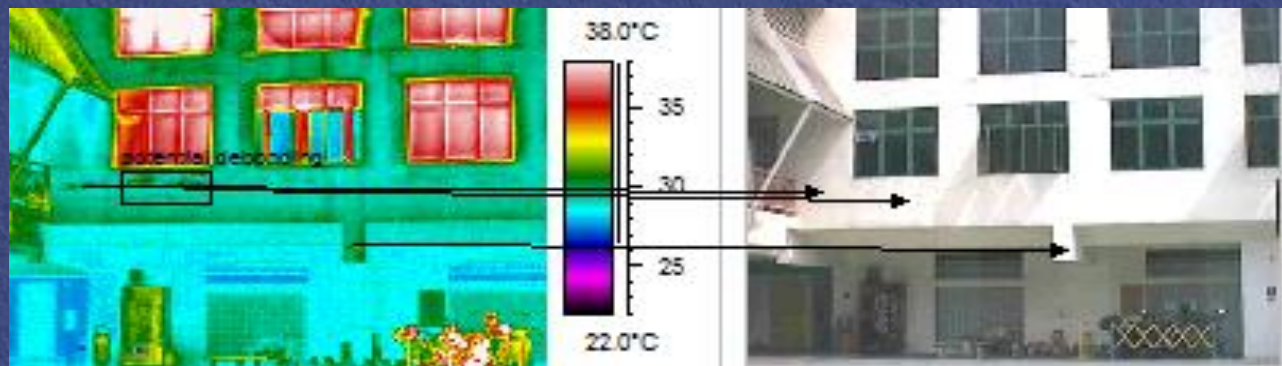
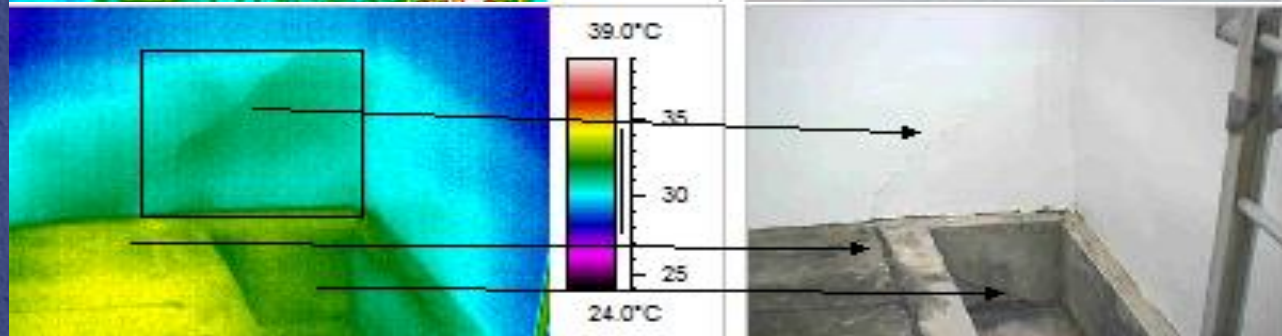
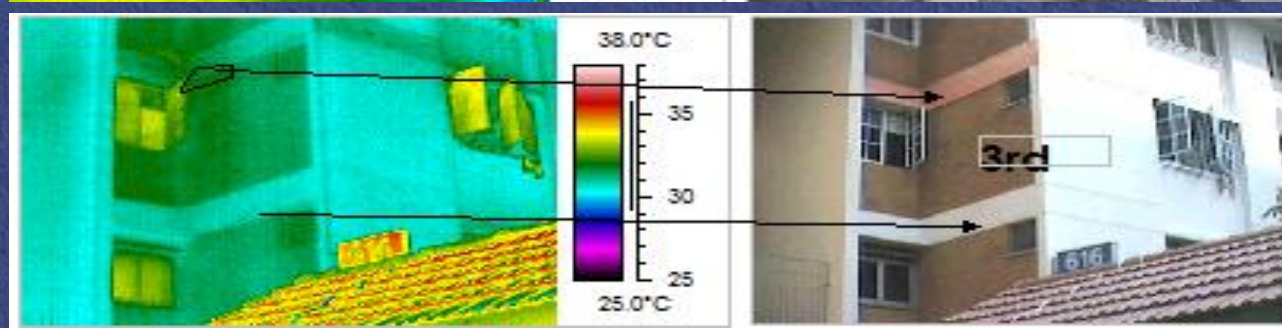
Potential
debonding
plaster to be
hacked and
restored

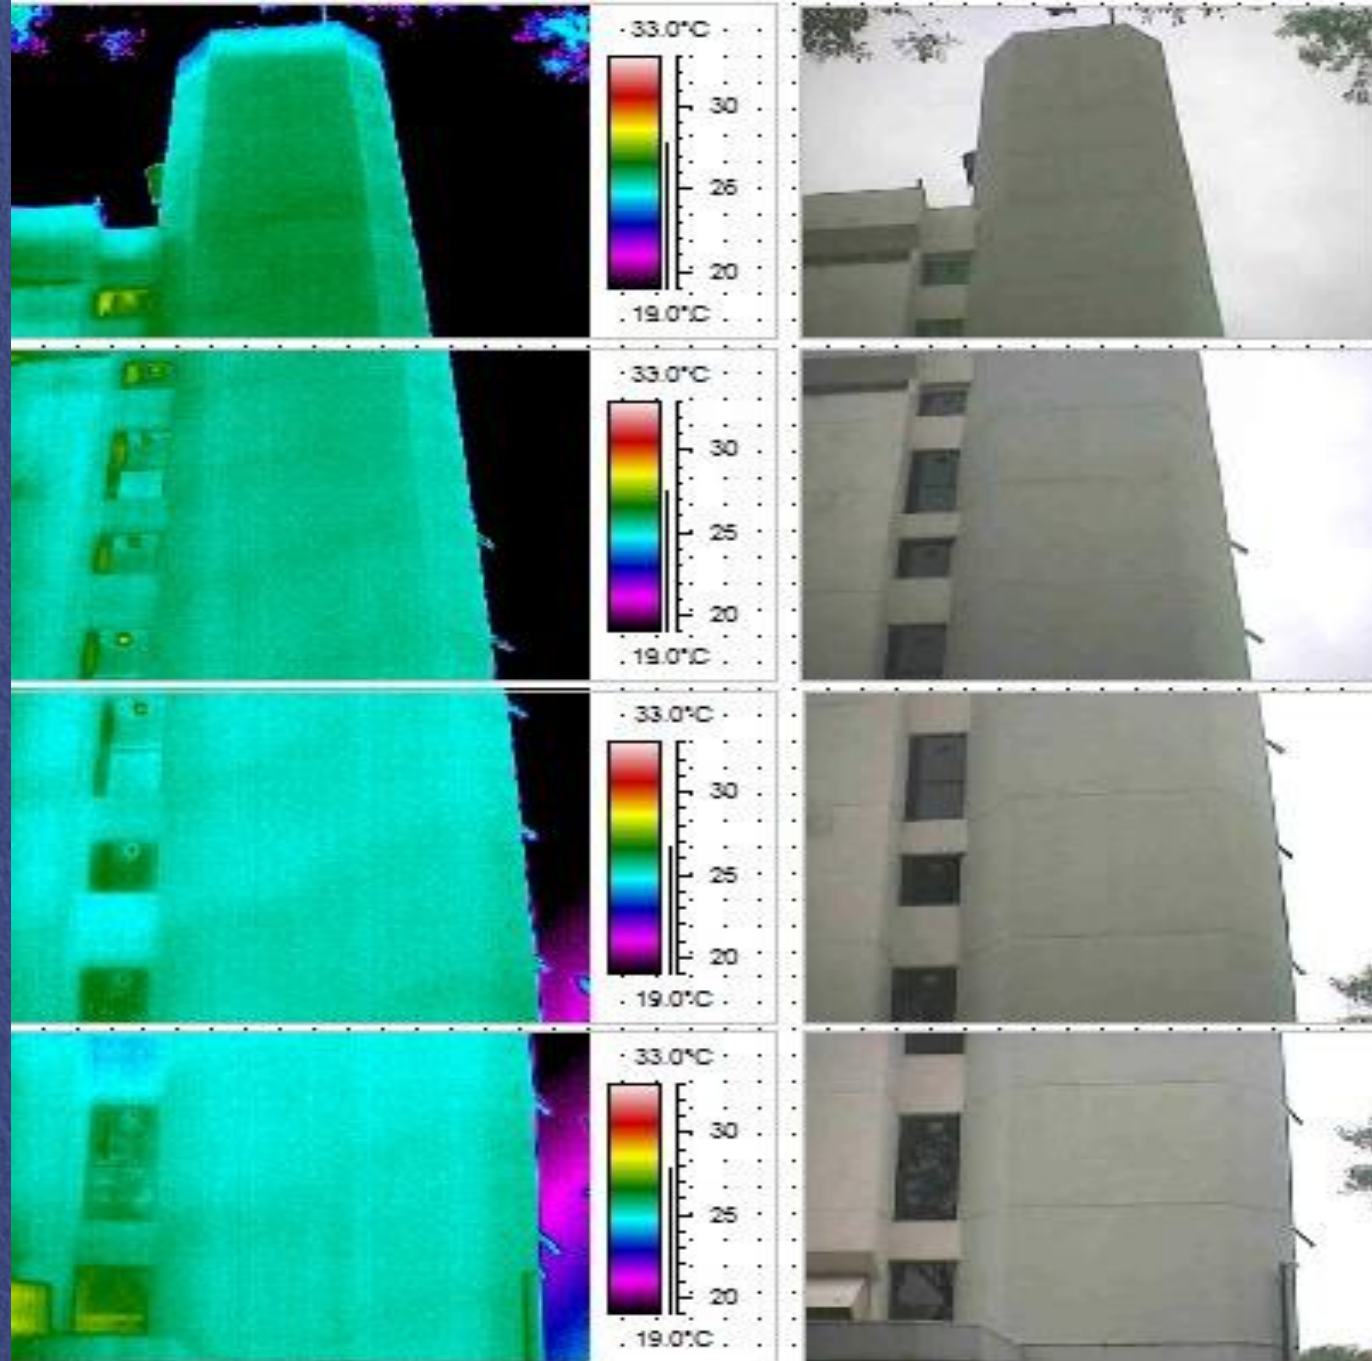
Facade in good condition, do not require repair works

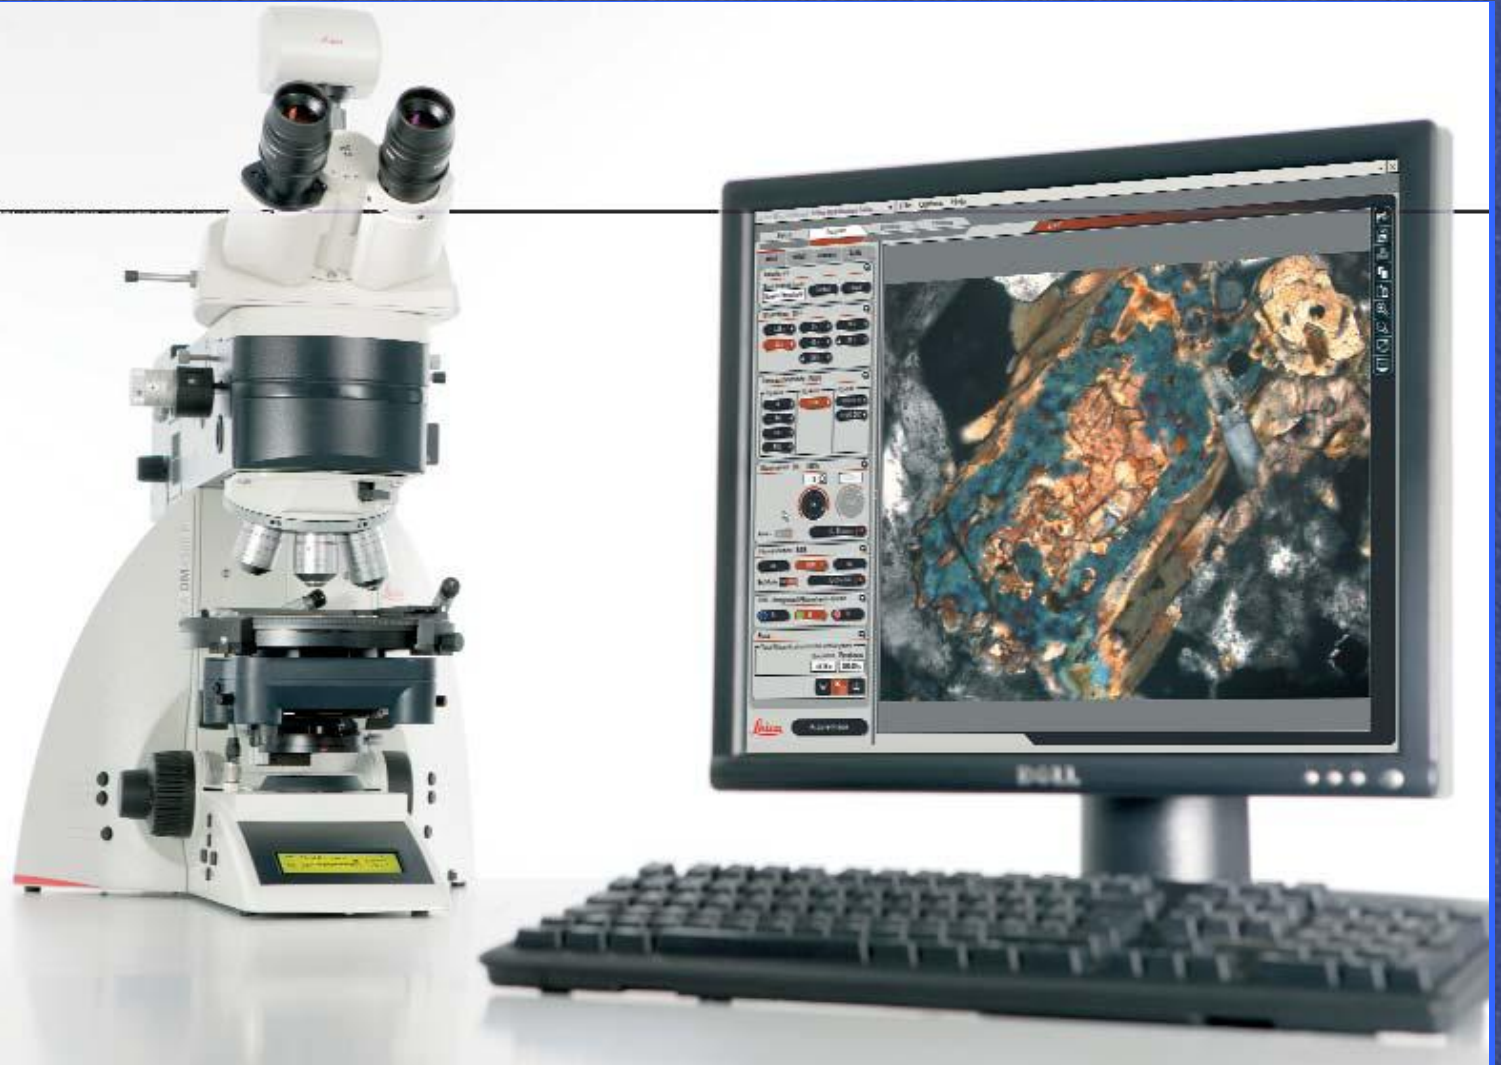
Polarised Optical Microscope

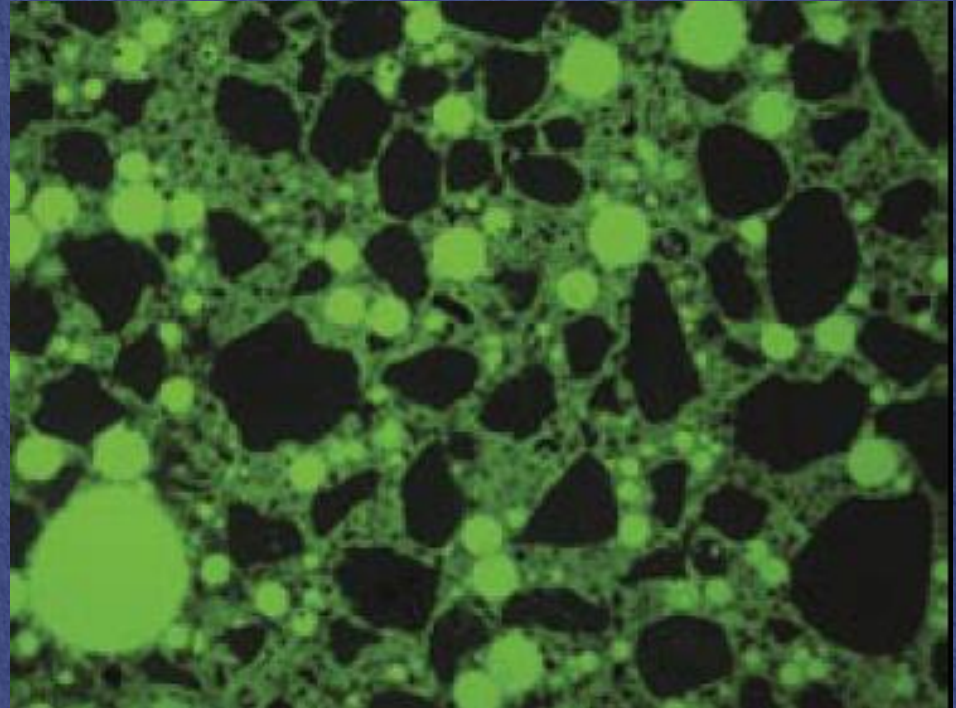
Microscope
photo of air
entrained,
homogeneous
concrete

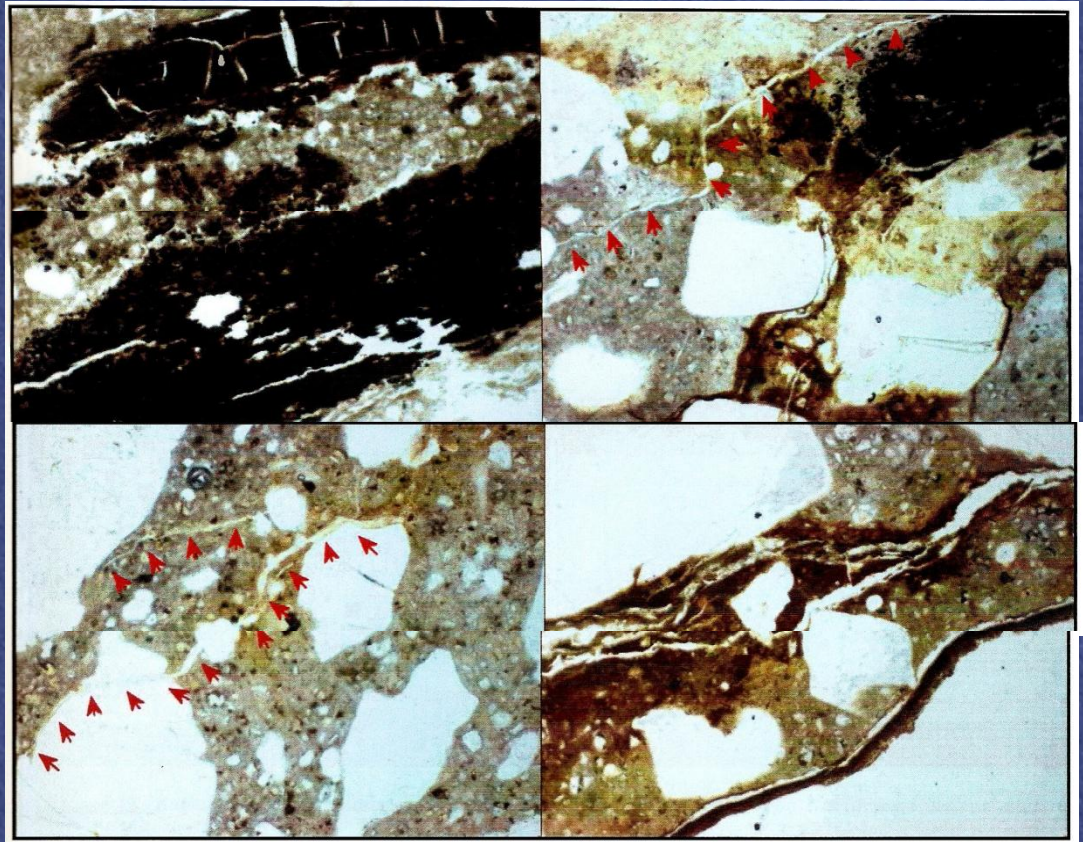
The photograph shows the cracked oxidized pyrite grain at the surface region, and extension of cracking and reddish brown iron oxide and hydroxide oxidation products into the neighboring paste. Field widths of all photos are 5 mm

Photomicrographs of thin sections of cores (in plane polarized light mode)

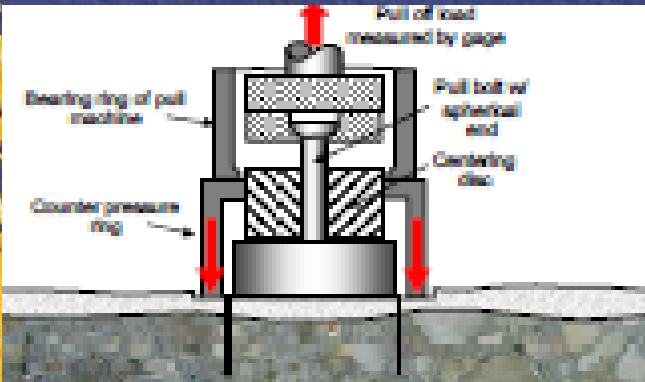
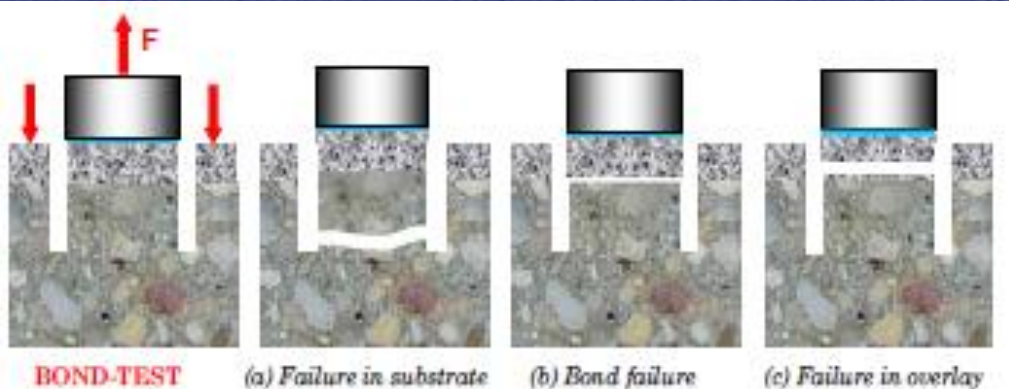
Pull-off Test

ASTM C1583/C1583M

- Direct tensile strength
- Evaluate condition of concrete surface before application of overlay or repair Material
- Measure bond strength of overlay or surface of repair materials
